Universal Safety Inspection Cage – Engineering Testing Results 2018

1.0 Test Reports

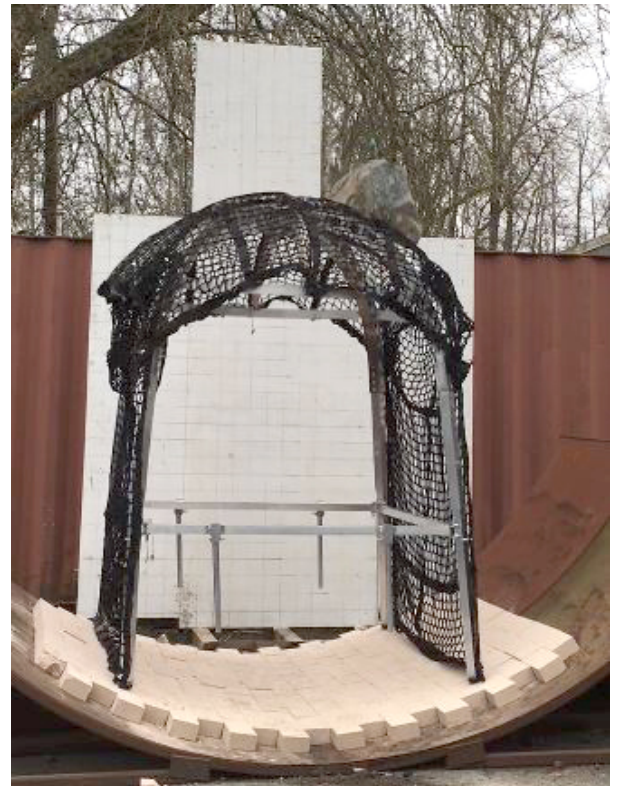
The rib had partially buckled and the net had some minor damage.

- 1.3.3** The rib impact fared better than expected. The rib buckled significantly and deflected down. The combination of the rib and the net stop the impactor but didn't capture it; this was desired. This impact is arrested more than the others and cage stability and flipping was a concern. However, this model uses spikes nested inside the rubber feet which bite into the brick and prevent the cage from flipping.

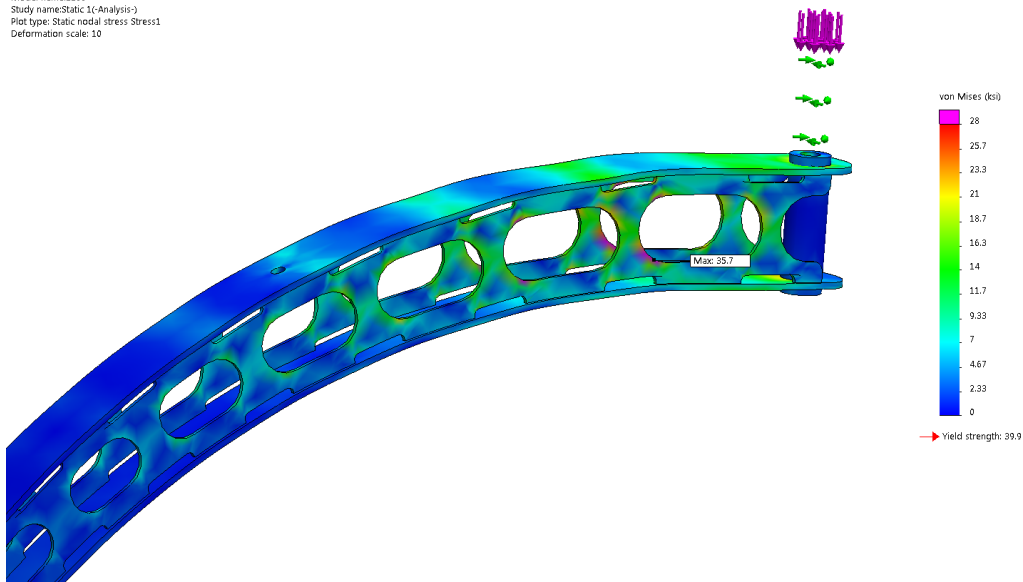
Model name: 2288
Study name: Static 1 (Analysis)
Plot type: Static nodal stress Stress1
Deformation scale: 10

- 2.1.1 Load Case – Vertical impact along the z-axis. One of four legs was analyzed.
- 2.1.2 Forces – Load was 2500 lbs. static directly above the pin sleeve.
- 2.1.3 Constraints – Pin sleeve was constrained from translation in the X and Y directions. Rotation was constrained in all directions. The foot was constrained from translation in all directions. Rotation was free in all directions.
- 2.1.4 Results I. – Stresses concentrated on the webbing with higher values near the pin sleeve. This is desirable as the yield failure will produce a cascading buckling from the top web working down the leg; absorbing the greatest amount of energy.

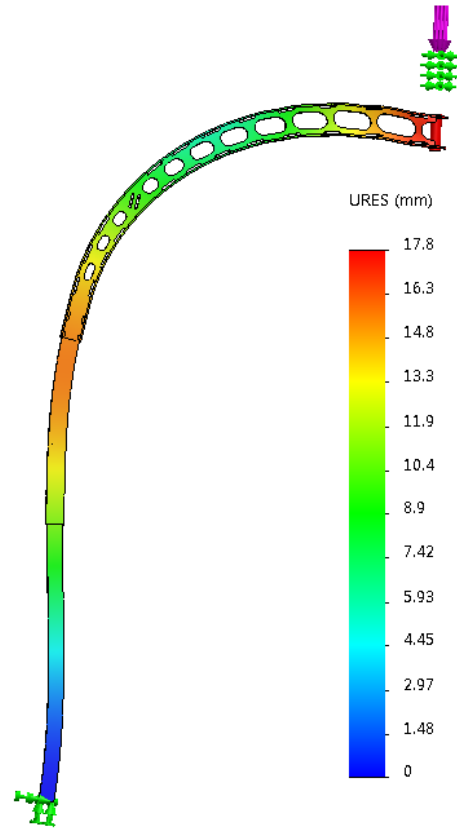
2.1.5 Results II. – Deflection was an “S” shape with a vertical change in height of 17.8mm.
