## SOUTH AMERICAN BRICKING SOLUTIONS

- N&S** A refractory bricking contractor in Chile has been using a Brokk tear-out robot and Bricking Solutions' pneumatic bricking machine to speed up cement kiln lining demolition and to accelerate and improve the quality of rebricking.
- N&S** Uma empresa de aplicação de tijolos refratários do Chile, para apressar a demolição do revestimento dos fornos de cimento e para acelerar e melhorar a qualidade do novo revestimento, tem utilizado um robô Brokk de arrancar tijolos e uma prensa pneumática de tijolos da Bricking Solutions.
- N&S** Un contratista chileno de ladrillos refractarios ha estado utilizando un robot de desgarrador Brokk y una máquina neumática para ladrillos de Bricking Solutions para agilizar la demolición del revestimiento del horno de cemento y para acelerar y mejorar la calidad del nuevo revestimiento con ladrillos.

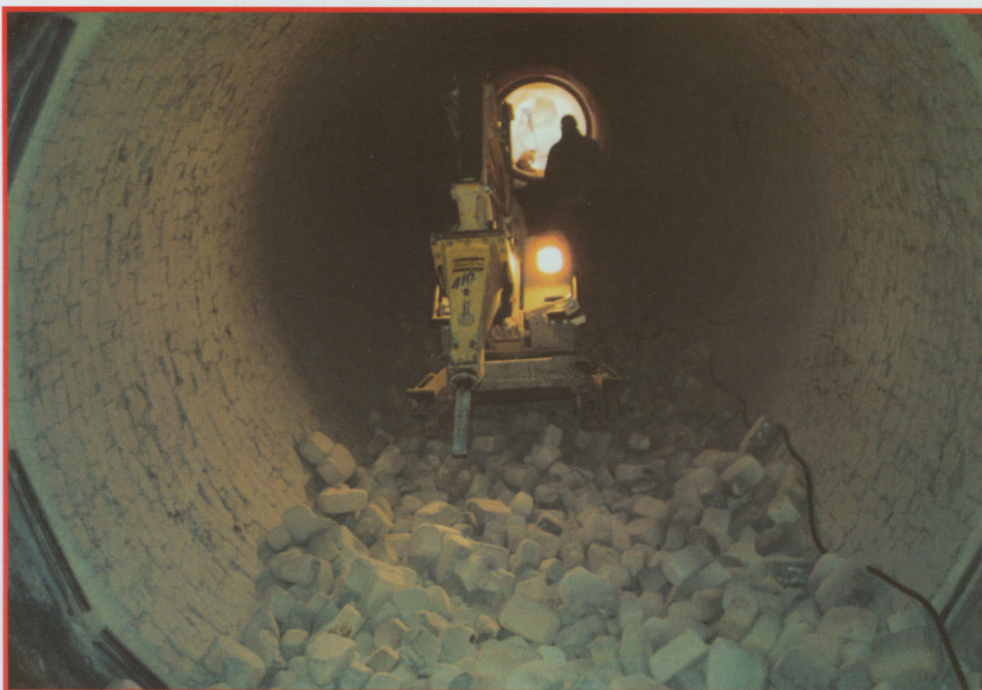
Below: A Brokk tear-out machine at work inside the kiln

"From the secondary aspect of minimising down-time, we have cut down-time to a fraction of what it used to be. The reduction in down-time was accomplished by utilising the Brokk tear-out robot, which saved an estimated 72 hours of demolition time, and through the use of a Bricking Solutions bricking machine, which installed brick at daily rates three times faster than traditional installation methods, with a record of 17.4 meters in 24 hours. Most important was the improved quality of installation. The Bricking Solutions machine, when properly-used, is not only the quickest installation method, but also the best from a quality point of view. The first installation with the Bricking Solutions bricking machine in Melon lasted 14 months.

The demolition rate with the Brokk was 8.3 meters per hour in the basic zone. The muck out rate with the Bobcat was greatly improved due to the new Bricking Solutions access ramp. Anders only had a short training time with the plant masons before the outage, but they managed to install 12 meters in 24 hours in the basic zone, compared to 8 meters using their old bricking machine. Installation rates in the alumina zone were slower due to the fact the plant masons had never installed with mortared joints before. Anders has also started work at Polpaico. Initial comments indicate similar good results to those obtained at Cemento Melon and Juan Minetti. **N&SAC**

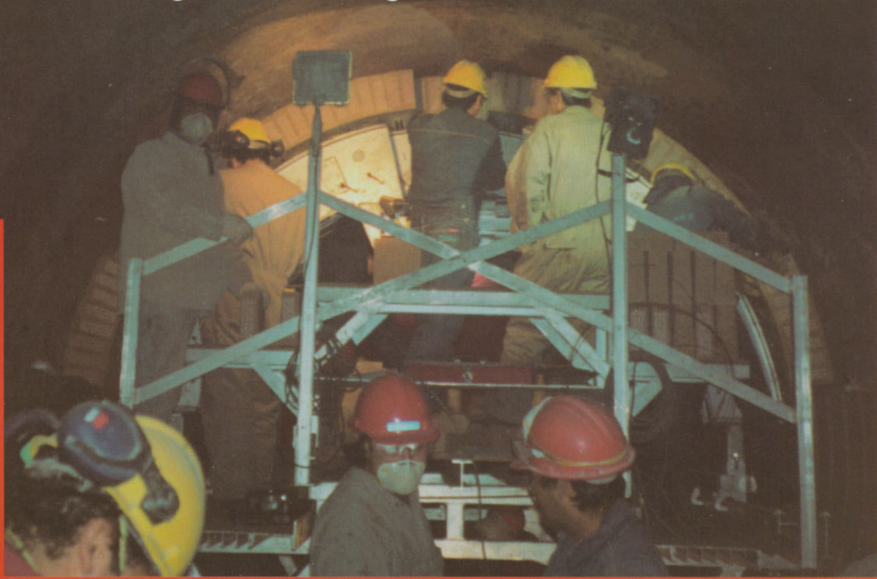
**Below: Bricking Solutions bricking machine inside the kiln at Juan Minetti**

Anders has now started projects at Juan Minetti and Polpaico. In the first outage at Juan Minetti he utilised a new Bricking Solutions access ramp, the Brokk tear-out machine, a Bobcat with a Muck-it bucket, and a Bricking Solutions adjustable 'Expand-O-Ring' bricking machine.
